# **INDOOR AIR QUALITY ASSESSMENT**

**Leominster Highway Department  
109 Graham Street  
Leominster, Massachusetts**

Prepared by:  
Massachusetts Department of Public Health  
Center for Environmental Health  
Emergency Response/Indoor Air Quality Program  
September 2006

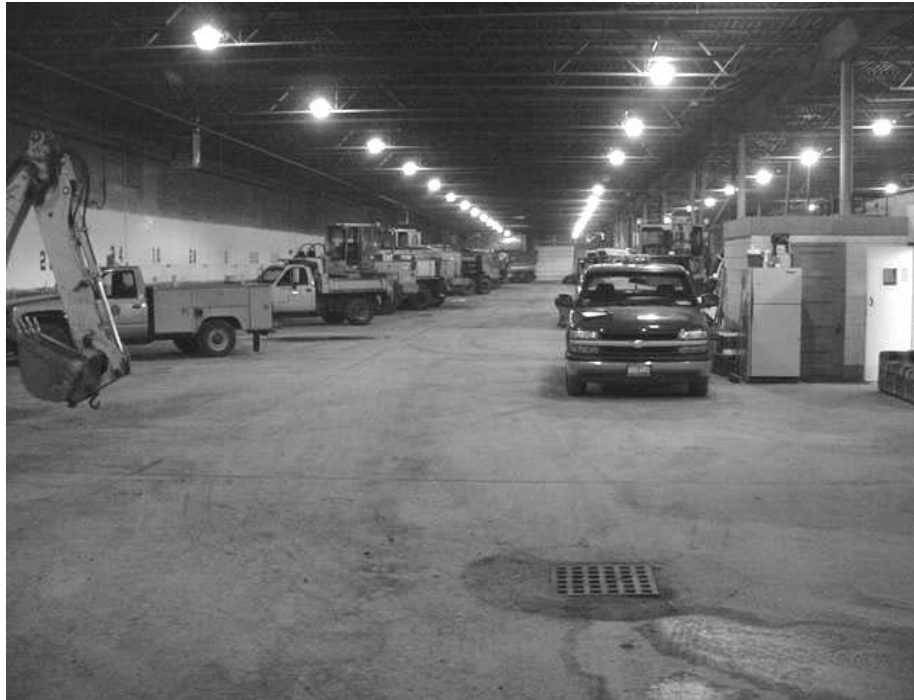
**Picture 1**

The LDPW is a cinderblock aluminum-sided structure that was built in the 1980s. The facility consists of a repair shop, multiple garage bays (Picture 1), garage, a large truck parking garage, office space, locker room and kitchen/break room. Windows in the offices are openable.

**Indoor Garage Parking Area**

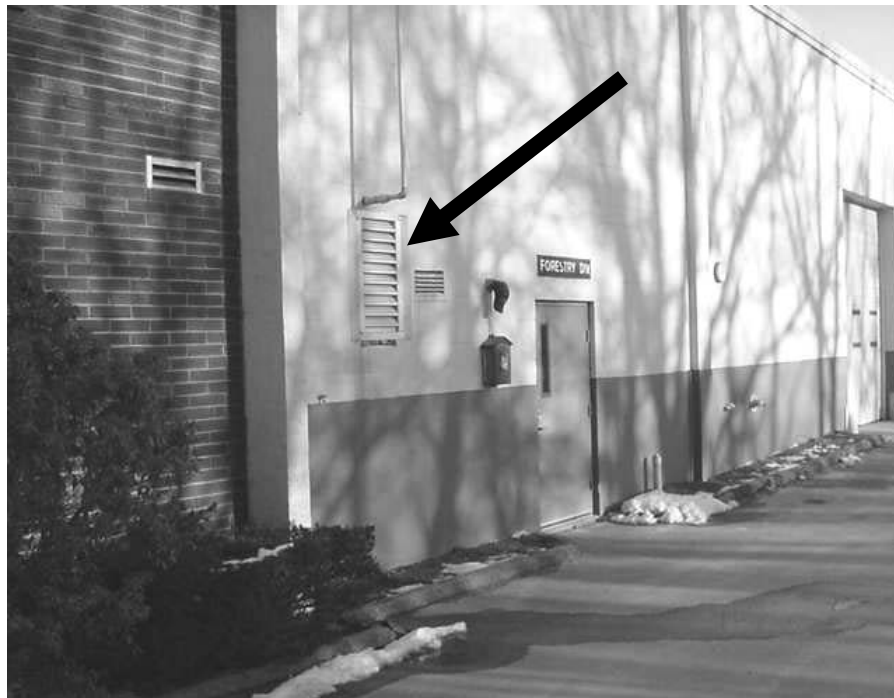
**Picture 2**

It can be seen from Table 1 that carbon dioxide levels were below 800 parts per million (ppm) parts of air in most areas surveyed, indicating adequate air exchange. Mechanical ventilation is provided by a heating, ventilating and air conditioning (HVAC) system. A wall air-handling unit (AHU) introduces fresh outdoor air to the offices (Picture 2). Conditioned outside air is distributed through ducted ceiling-mounted supply vents and returned to the AHUs by ducted ceiling-mounted return vents.

**Fresh Air Intake for Office AHU**

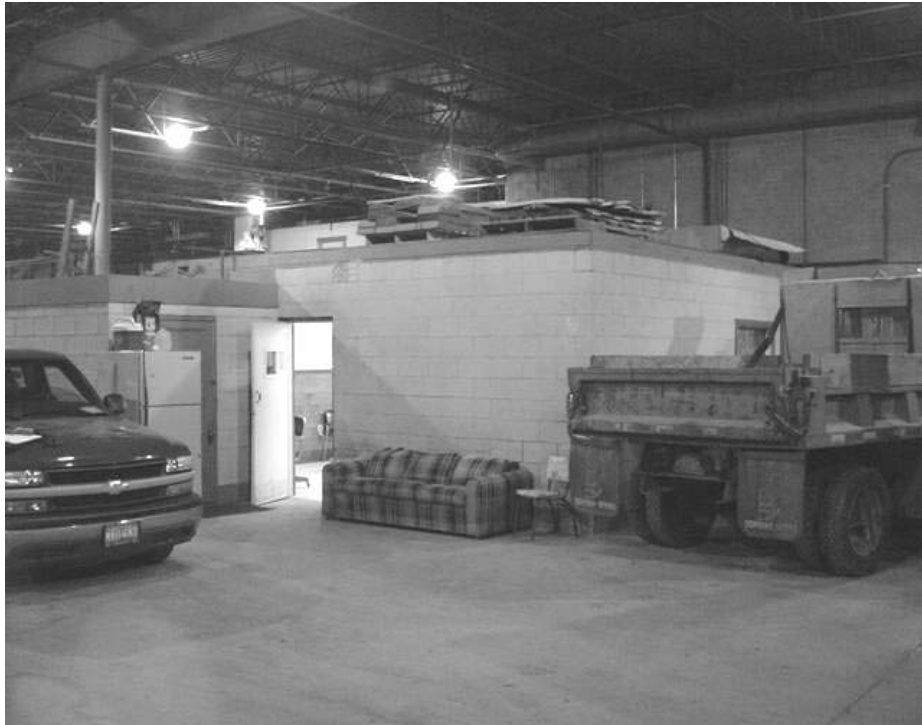
**Picture 3**

A free standing structure in the garage functions as the break room (Picture 3). This room has no mechanical ventilation system. Ventilation is provided by open doors in the garage.

**Break Room in Garage**

7. Examine the feasibility of installing a mechanical ventilation system for the break room.
8. Identify and seal any utility holes in the shared walls of the office and garage and their terminus to reduce/eliminate pollutant paths of migration.

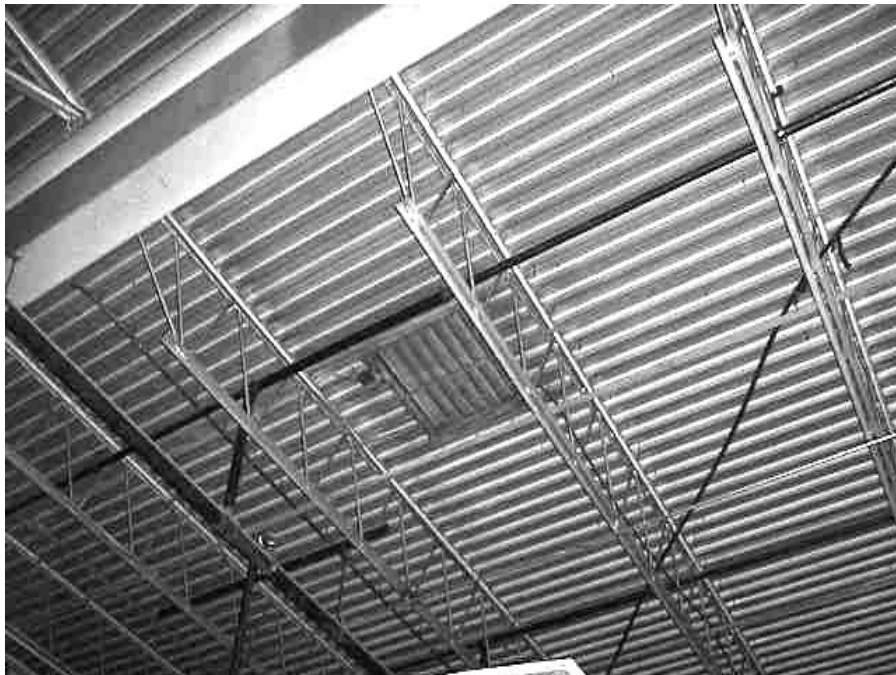
**Picture 4**

Local mechanical exhaust ventilation systems are installed in the garage ceiling (Picture 4) and repair shop (Picture 5) to remove airborne pollutants (e.g., odors, fumes, carbon monoxide and other products of combustion) from the garage and repair shop. The systems are described in detail under the Specialized Local Exhaust portion of this report.

The LDPW is equipped with a ceiling-mounted mechanical exhaust system to remove exhaust emissions and other pollutants from the building. Ceiling exhaust fans can mix and draw vehicle exhaust upwards. This mixing phenomenon provides the potential for vehicle exhaust to penetrate office areas through the holes and spaces noted in the office walls. A more effective method of exhaust ventilation would be to locate exhaust fans in the wall next to the parked vehicles, to draw exhaust away from the offices and break room.

**Example of Exhaust Fan in Ceiling of Garage and Repair Shop**

1. Repair the exhaust ventilation system for welding activities in the repair shop.
2. Consider consulting with an industrial hygienist for the best methods to provide exhaust ventilation for welding operations in the repair shop.
3. Consider installing exhaust fans in the wall along the parking area for LDPW vehicles. Use of these fans would necessitate having vehicles the back into spaces to effectively draw vehicle exhaust outdoors.
4. Contact an HVAC engineering firm for possible solutions (e.g., roof) for providing outside make up air for the mechanic's bay. Continue to operate local exhaust system in mechanics' bay during hours of occupation. Due to the type of materials used (e.g., solvents, paints, fuels), consider installing an automatic timer to operate the system continuously during occupied hours.
5. Keep all office doors accessing the garage closed at all times.

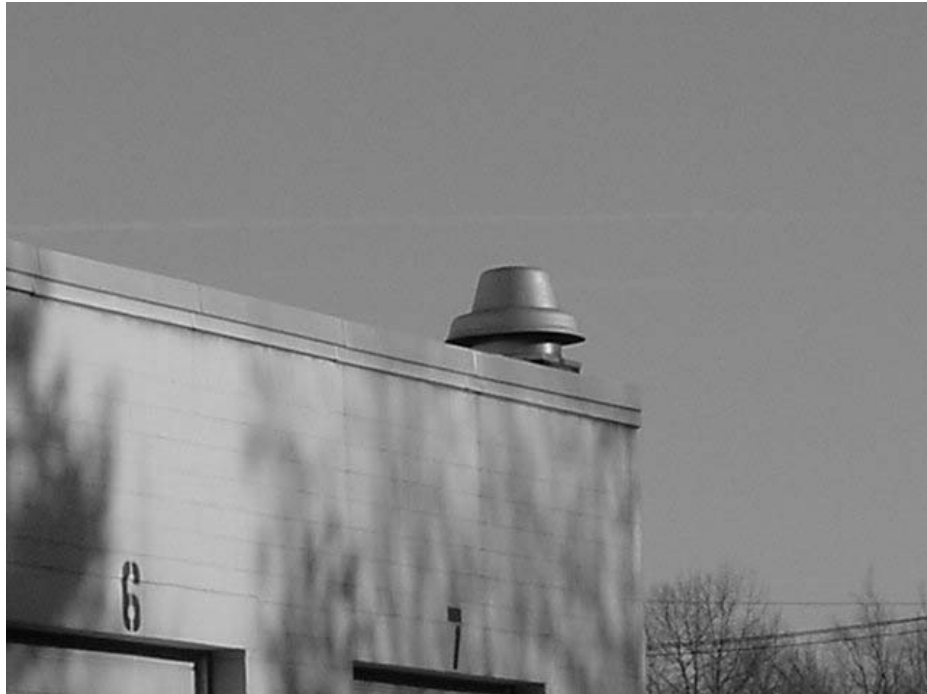
**Picture 5**

**Example of Exhaust Vent on Roof**

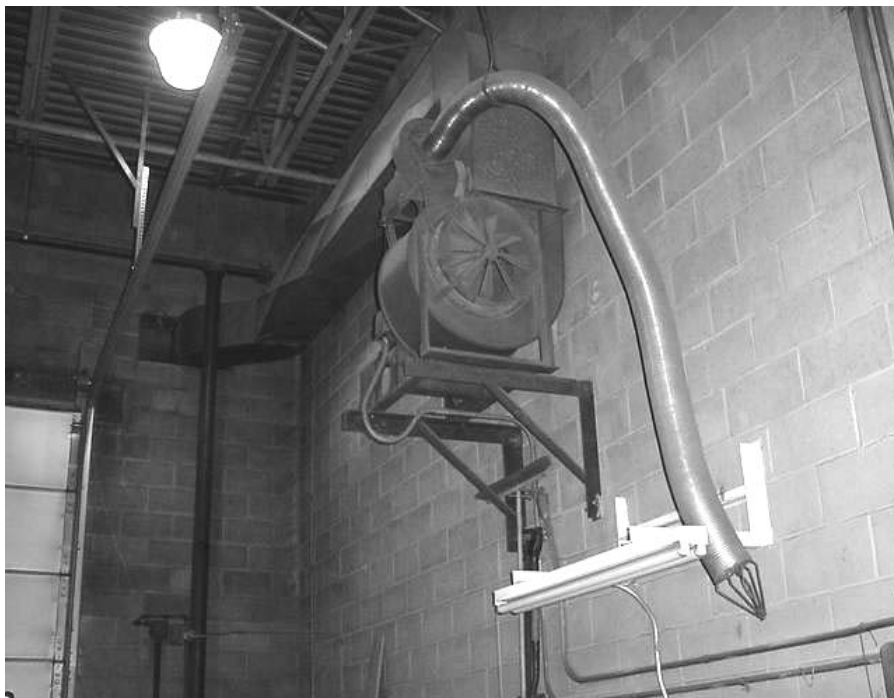
**Picture 6**

During the assessment, CEH staff observed welding in the repair shop. Exhaust ventilation equipment exists in this space, but was *not* used during welding (Picture 6). The repair shop also has a ceiling exhaust fan, which also was *not* operating during this assessment. Exposure to welding fumes is associated with a number of health effects. “Acute exposure to welding fumes can result in eye, nose, and throat irritation, fever, chills, headache, nausea, shortness of breath, muscle pain, and a metallic taste in the mouth. Chronic exposure to welding fumes can result in respiratory effects including coughing, wheezing, and decreased pulmonary function” (OSHA, unknown). The National Institute for Occupational Safety and Health (NIOSH) has established a recommended exposure limit (REL) for welding fumes (and total particulates) of the “lowest feasible concentration,” since NIOSH considers welding fumes potential occupational carcinogens (NIOSH 1992). For this reason, exhaust ventilation for welding operations should be designed in a manner to draw fumes away from the welder. The repair garage welding exhaust ventilation system did not appear to be equipped with flexible ducts of adequate length to provide an adequate means to draw welding pollutants away from the operator. To reduce exposure, a flexible hose connected to a fume venting system should be placed in a location opposite the operator and point of welding. Refer to [Appendix B](#) for additional information concerning welding occupational safety.

**Welding Exhaust Vent**

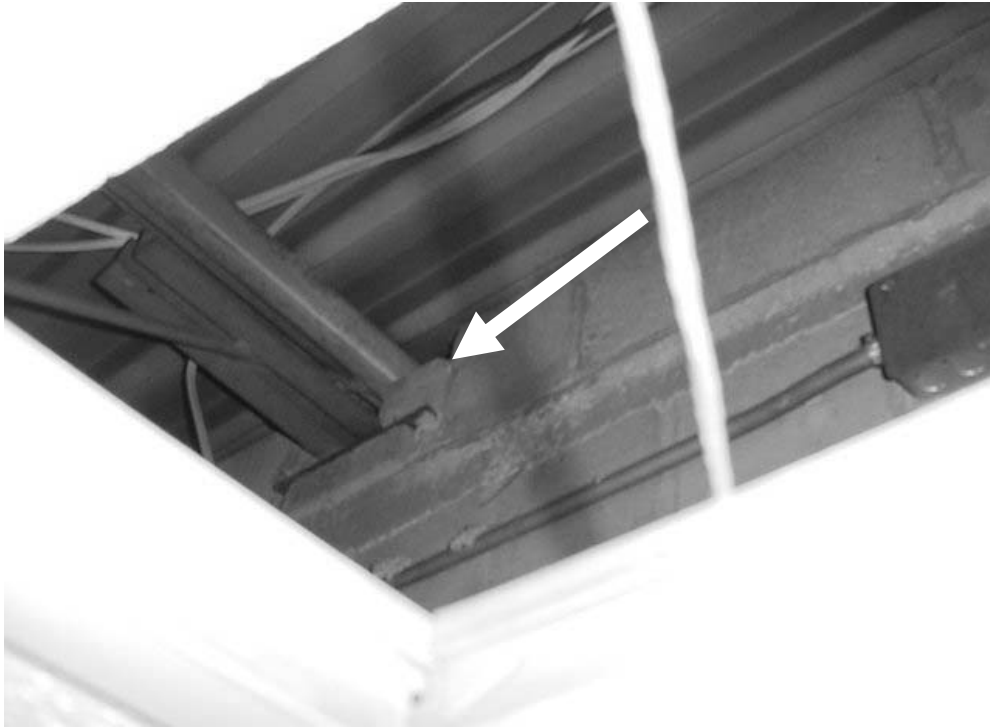
**Picture 7**

Several potential pathways for exhaust emissions and other pollutants to migrate into occupied areas were identified. The doors to the offices had spaces beneath the door where light could be seen penetrating. The ceiling/walls of the garage and offices are penetrated by holes for utilities or roof trusses (Pictures 7 to 9). If they are not airtight, these holes can serve as potential pathways for particles to migrate into occupied areas. Each of these conditions presents a pathway for air to move from the garage to adjacent areas. In order to explain how these pollutants may be impacting adjacent areas, the following concepts concerning heated air and creation of air movement must be understood.

**Hole in Wall Shared By Office and Garage above Ceiling on Office Side**

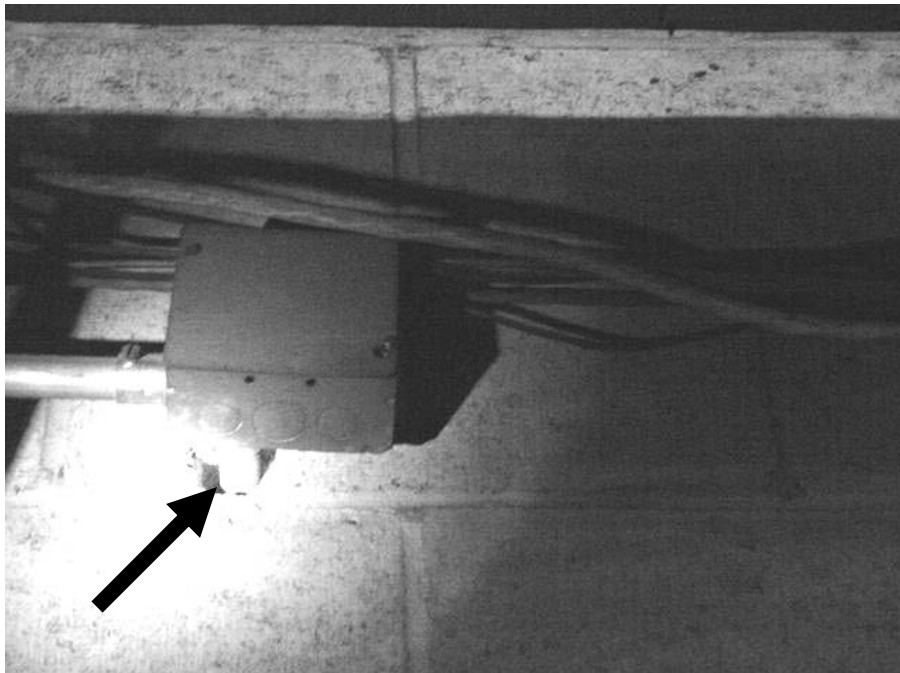
**Picture 8**

**Hole in Wall Shared By Office and Garage, Garage Side**

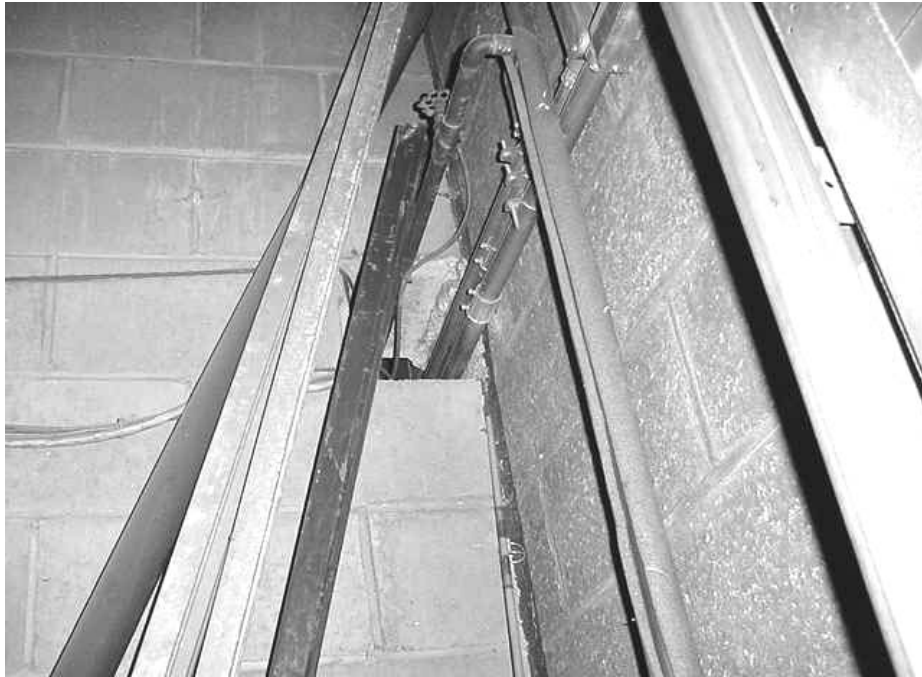
**Picture 9**

**Hole in Wall Shared By Office and Garage, Garage Side**
